## Boxwood Gulch Private Fishing Ranch North Fork of the South Platte River Enhancement Project 2006

Photo 1 shows overly wide channel section, shallow low flow water depth and lack of any in-stream holding habitat prior to enhancements.

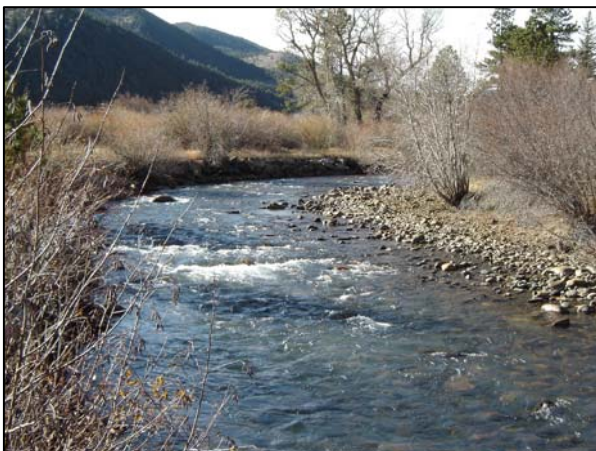
Photo 5 shows a bend pool area with no defined riffle or pool, outside bank erosion, limited water depth and under developed point bar during low flow conditions prior to enhancements.

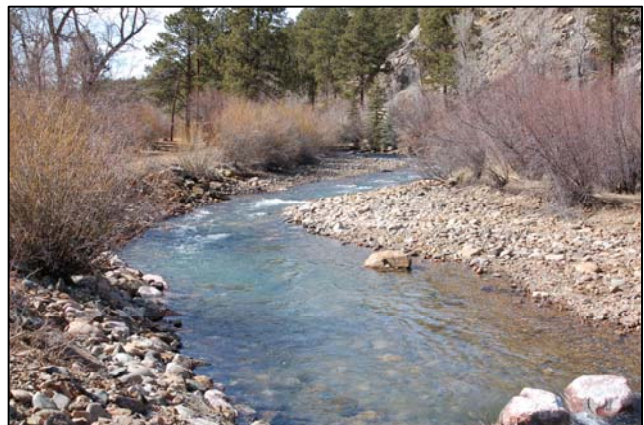
Photo 6 shows an enhanced bend pool area with stable banks, well defined riffle-pool and point bar (right).
